Manhole Inspection Summary

Manhole # S47I__019MH

Insp Date: **12/2/08 10:24 AM**

Location Address: **2233 eastern av** Cross Street: **s patterson park**

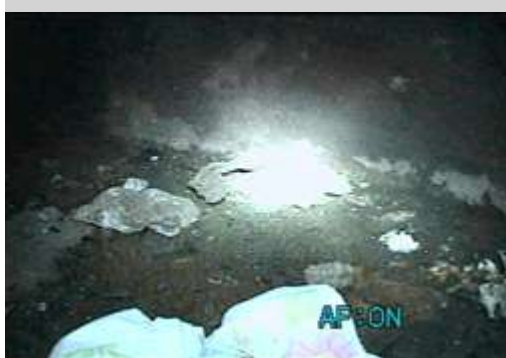
Defect 4

Condition: ☐ Sound ☐ Cracked ☐ Root Intrusion ☐ Deteriorated ☐ Leaks ☒ **Debris**

bench debris

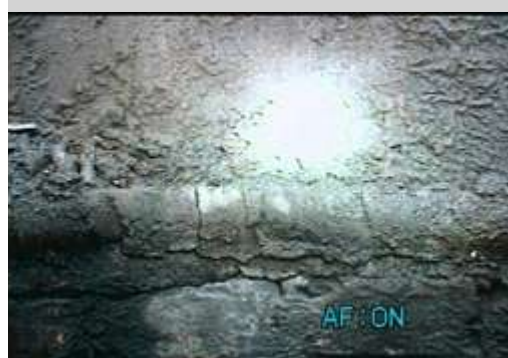
Defect 3

Condition: ☐ Sound ☒ **Cracked** ☐ Root Intrusion ☐ Loose Brick ☒ **Deteriorated**

Infiltration: ☐ None ☒ **Joint** ☐ Cracks ☐ Mortar ☐ Roots ☐ Wall

chimney cracked, deteriorated, infiltration frame adj

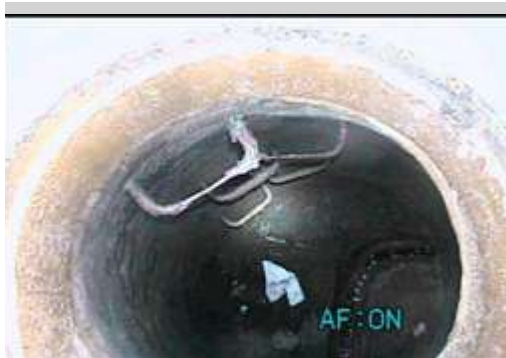
Defect 2

Steps Count: **5** Missing: **0** ☒ **Corroded**

corr steps

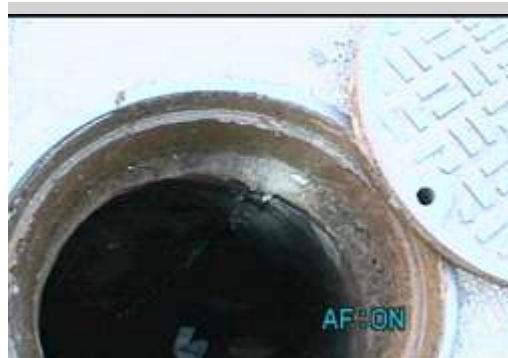
Defect 1

Frame Offset: **2** (in.) Condition: ☒ Sound ☐ Cracked ☐ Leaks

offset

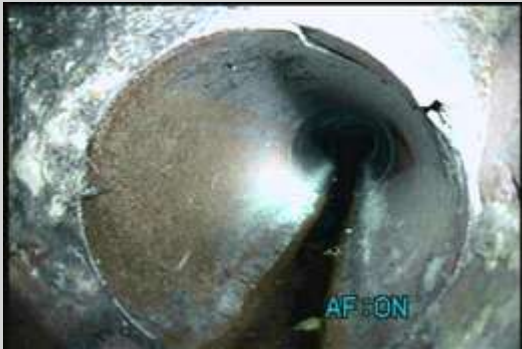
12 O'Clock Outflow

broken pipe
